Re: Notice of Violation  
Compliance Evaluation Inspection  
MND 980 996 805

# Photographs for Enviro-Chem CEI 7/29/2014

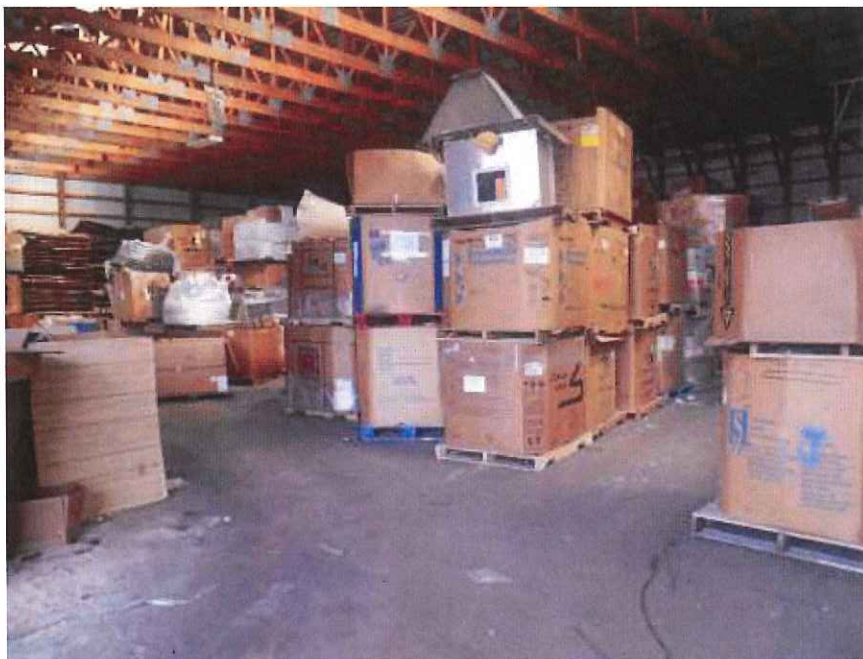
Storage of metal items, inside the building, that have been received. The items are stored here prior to shredding and shipping to the main facility for precious metal recovery.

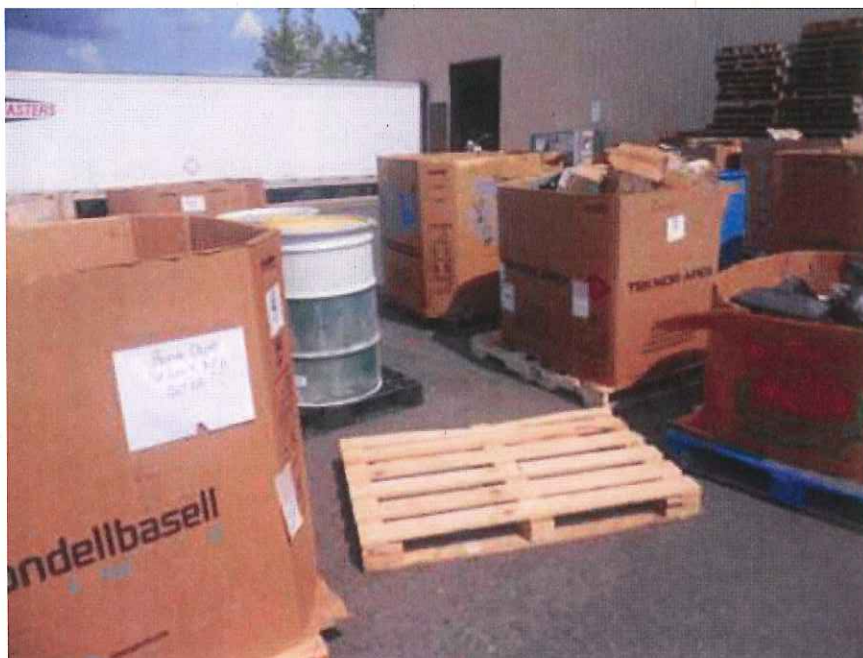
Storage of metal items, outside the building, that have been received. The items are stored here prior to shredding and shipping to the main facility for precious metal recovery.

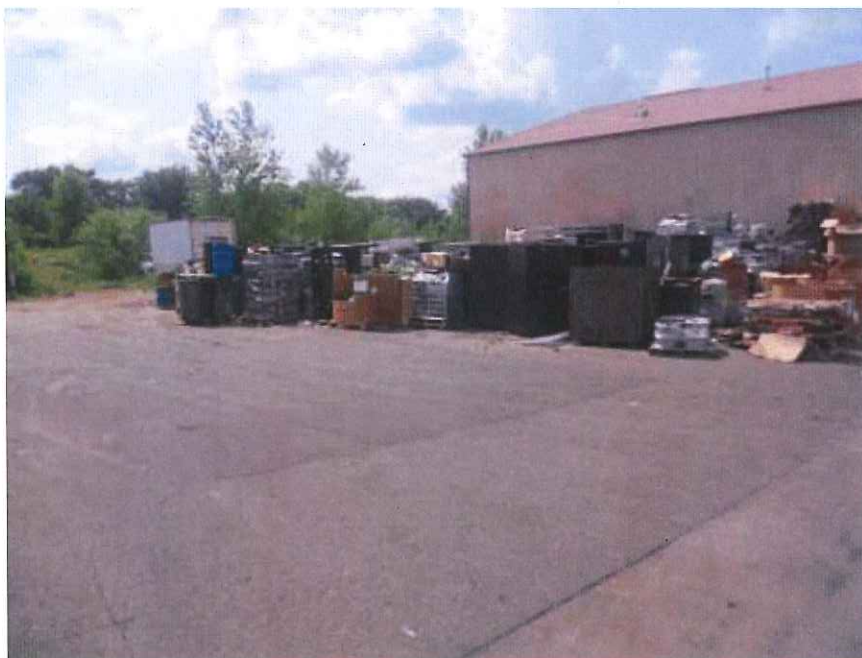
**Disk Number** 1  
**Photo Number** 46  
**Photo Filename** DSCN0718.JPG  
**Date/Time** 7/29/2014  
2:57:00 PM  
**Photographer** Jamie Paulin

Storage of metal items, inside the building, that have been received. The items are stored here prior to shredding and shipping to the main facility for precious metal recovery.

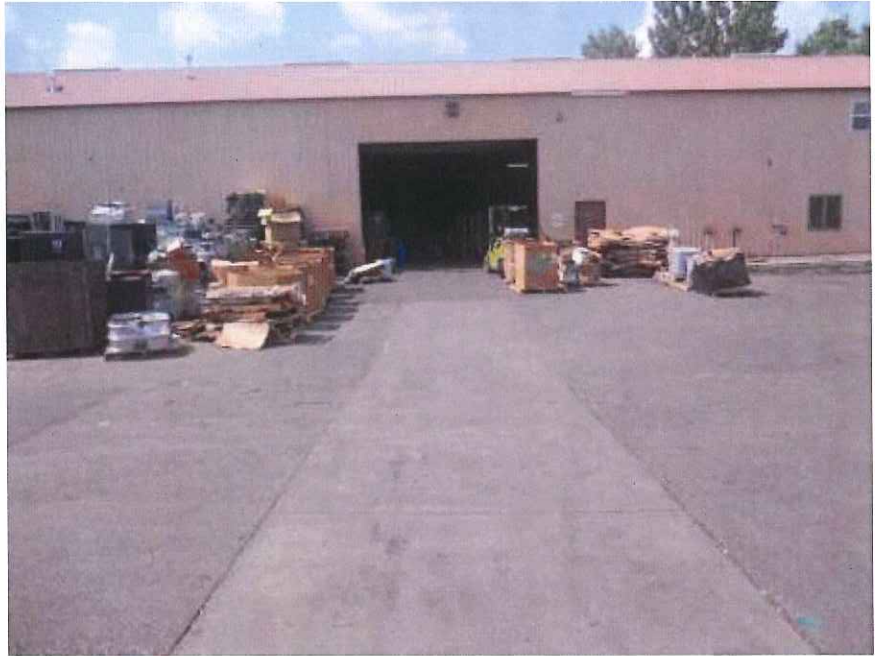
Storage of metal items, inside the building, that have been received. The items are stored here prior to shredding and shipping to the main facility for precious metal recovery.
